PHASE I ENVIRONMENTAL AUDIT

Penn Plaza
1727 Pennsylvania Avenue
Bremerton, Washington

Subject: PHASE I ENVIRONMENTAL AUDIT
Penn Plaza
1727 Pennsylvania Avenue
Bremerton, Washington

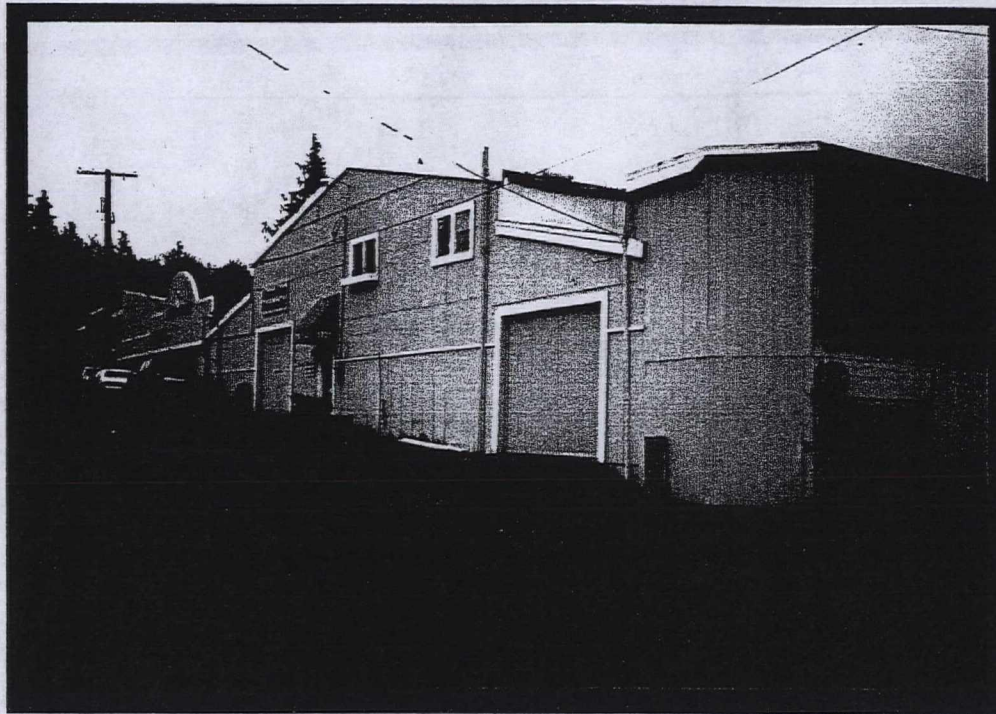
1

View of the subject property from the northeast. Adjacent buildings B-3, B-2 and B-1 visible from foreground to left background.

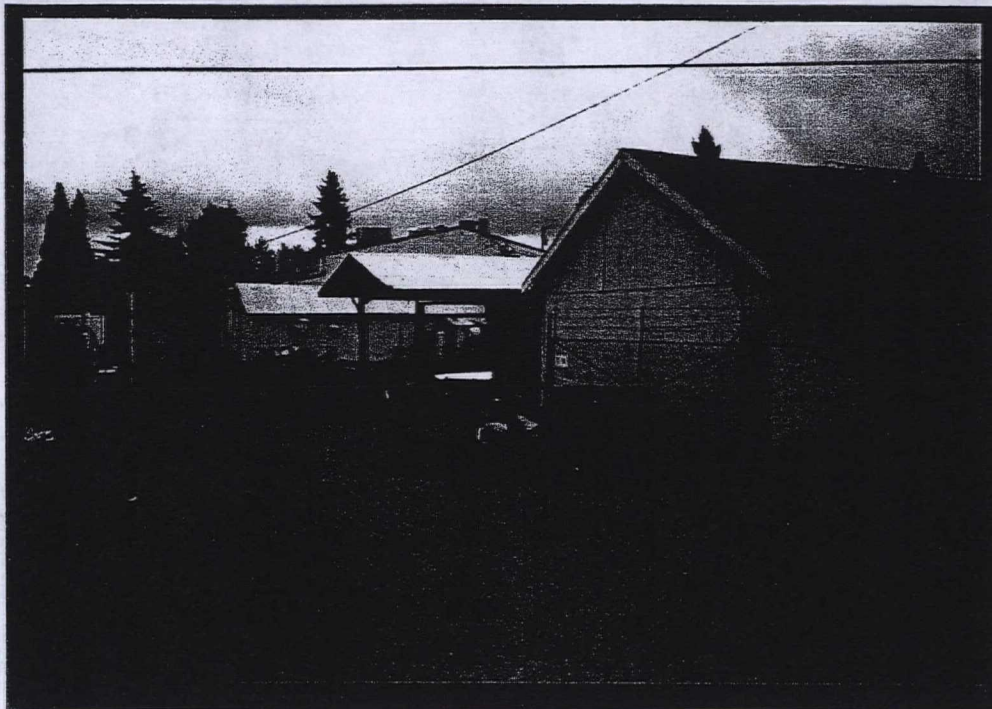
2

View of the subject property from the west. Building B-6 unit A visible at right, shed at center of photo, and portion of building B-3 at left rear.

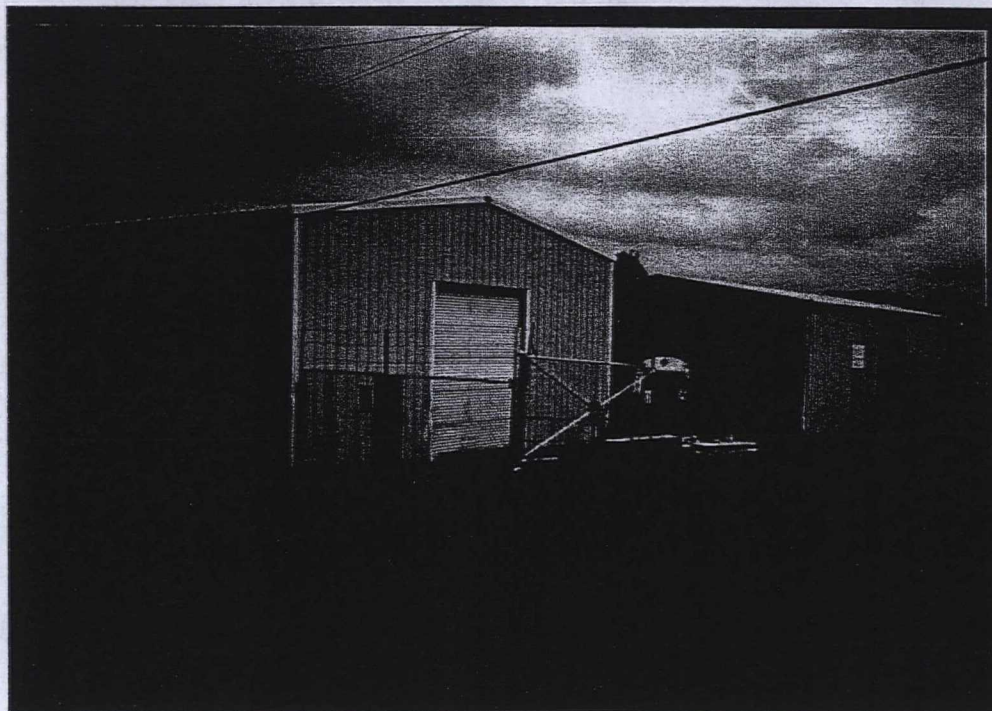
View of the northern portion of the site showing buildings B-4 and B-5.
View looks toward the east-northeast.

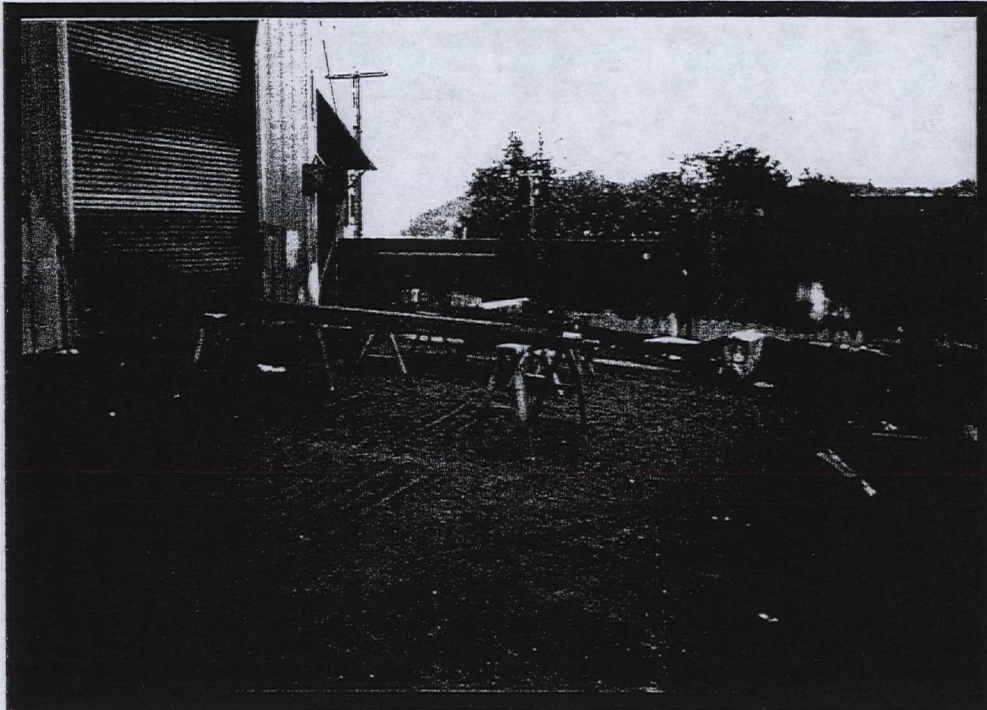
3

- Sandblasting grit spread over a large area at the north of the property. This grit was present during our site visit, and appeared no different than conditions noted in Ecology site photographs in 1992.

View of the sandblasting area east and north of building B-5 occupied by Lee Fabricators. Northern property line is roughly defined by wall at rear of photo. Shed barely visible at right edge of building is a former paint booth.

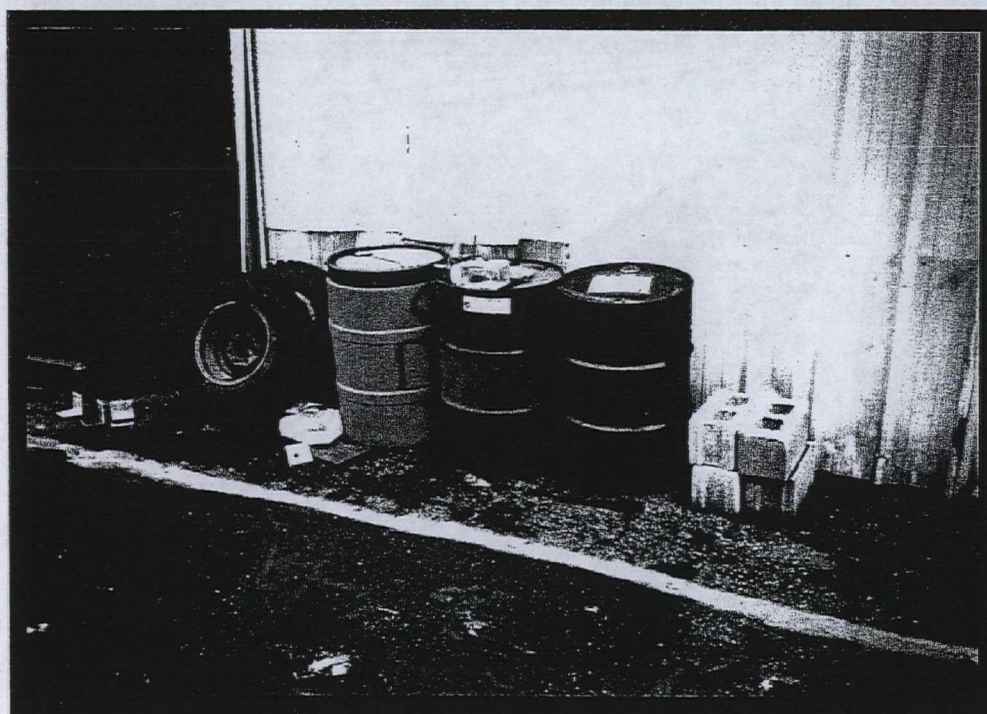
View of the oil storage drums adjacent to the west side of building B-4 occupied by Pacific Coast Energy's truck repair facility. Note labels on drums.

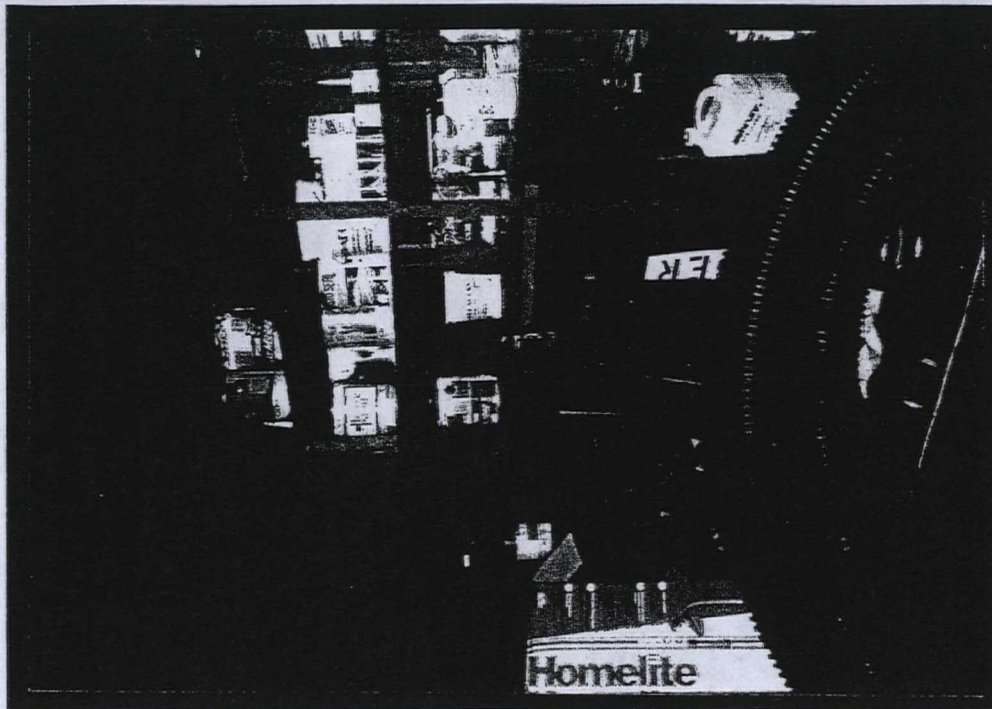
4

Typical view of the interior spaces of building B-3. This is the area used for storage of maintenance items by Mr. McConkey.

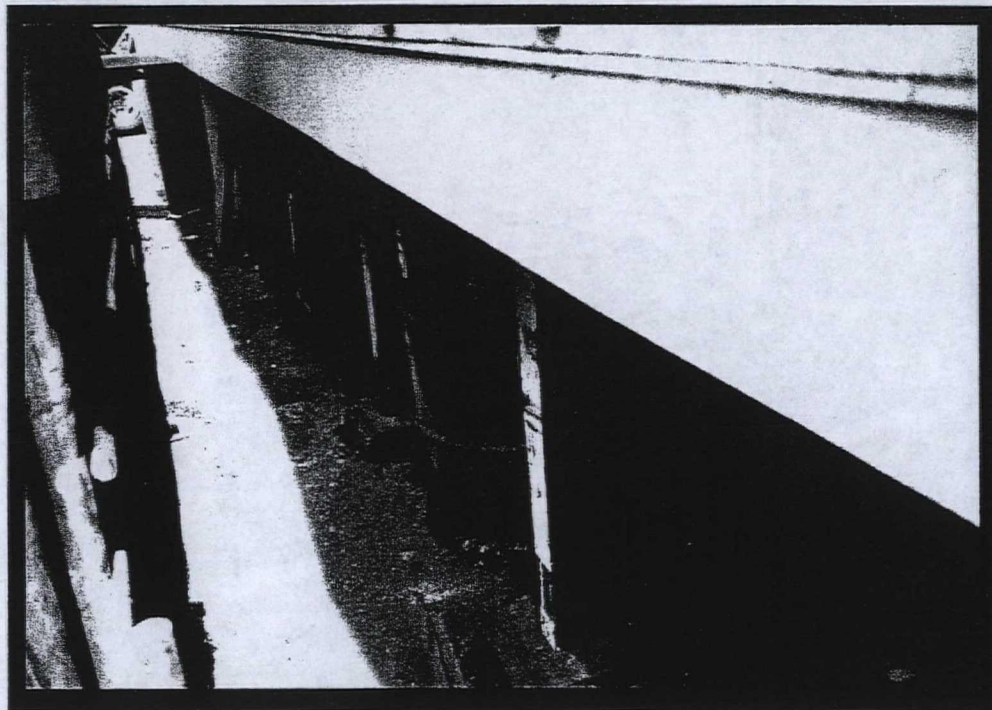
This building was being cleaned up for imminent move-in by a propeller repair company, the company name of which Mr. McConkey could not remember at the time of our site visit. Prior to CLM Pet Supply, the site was occupied by a heating contractor, and was formerly utilized by Lent's as their lighting fixture showroom and retail sales area. This building had painted concrete block walls, and a carpeted office area with sheetrock walls. Heating to the building is supplied by roof-mounted HVAC systems. At the rear of this building is a closed-in (by sheet metal) loading dock, beneath which we identified approximately three drums containing unknown materials (see Plate 5). We were unable to move these drums for access, therefore we were unable to inspect their contents. The drums were unlabeled.

View of the drum storage area of unknown materials beneath the loading dock of building B-1, which will be occupied by a propeller repair company in the near future.

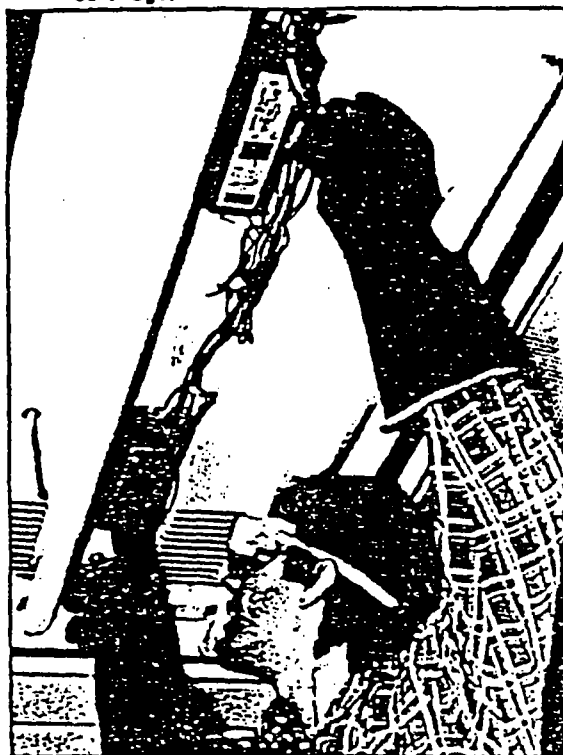
Once you have removed the fluorescent tubes and the control cover, you will be able to easily locate the ballast(s). Note the gloves and goggles worn to prevent possible personal contact with PCBs.

2. Turn off the light fixture at the switch and disconnect electricity at the fuse or breaker box. Let the ballast unit cool for 20-30 minutes before proceeding.
